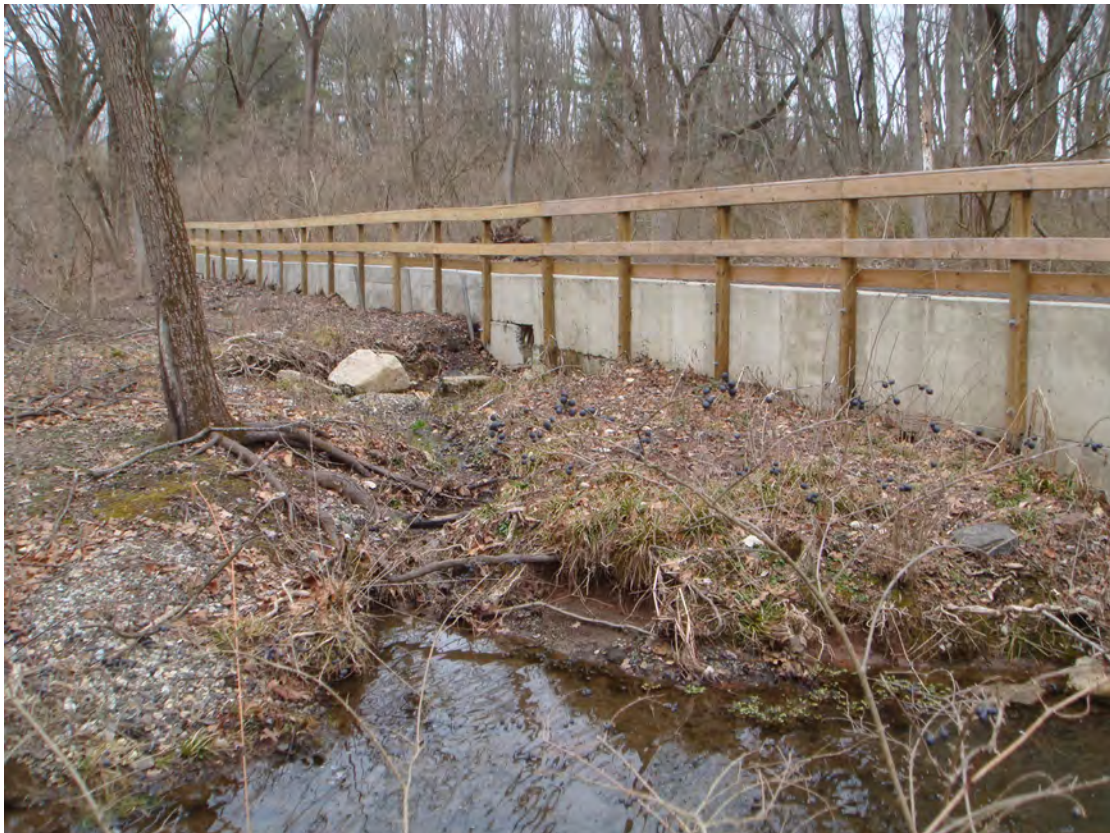
Before - Eroded stormwater channel leading to creek. Roots of black walnut exposed.

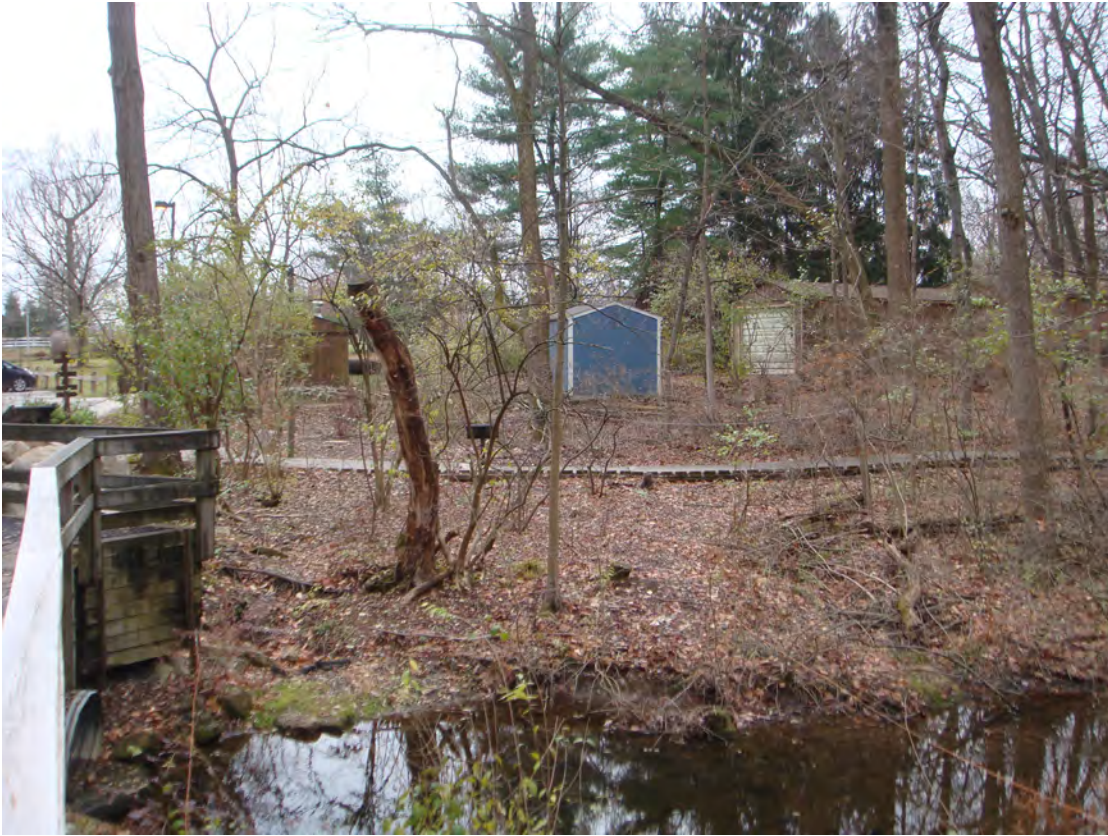
Before - Two eroded stormwater channels (right and left sides) and eroded streambank (middle). Also many exotic plants (bush honey suckle and privet).
